CRASH INJURY BULLETIN

**MODIFICATIONS TO THE PASSENGER SEAT-BELT
TIEDOWN ATTACHMENTS IN THE**

U.S. ARMY HU-1 SERIES BELL IROQUOIS HELICOPTER

TCREC Technical Report 62-45

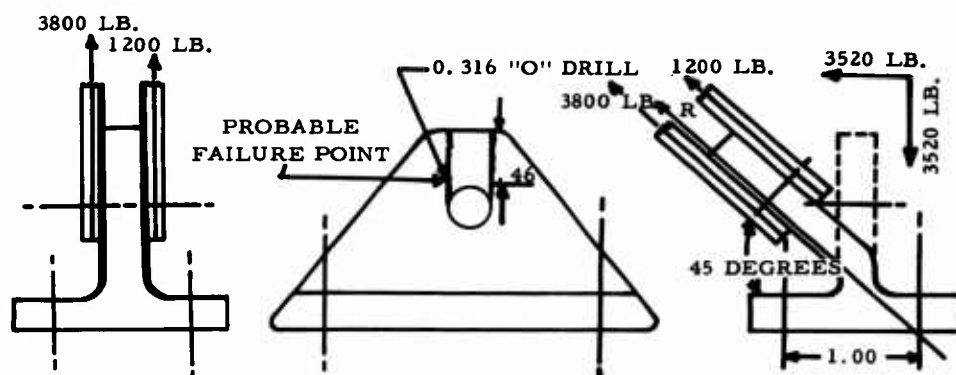
STRESS CHECK MADE ON 1020 MILD STEEL:

Check of 3/16-Inch-Diameter Tiedown Bolts:
